APPENDIX A. JSC PHOTOGRAPHIC ANALYSIS SUMMARY

STS-101 Summary of Significant Events

July 6, 2000

Project Work Order - SN3CS

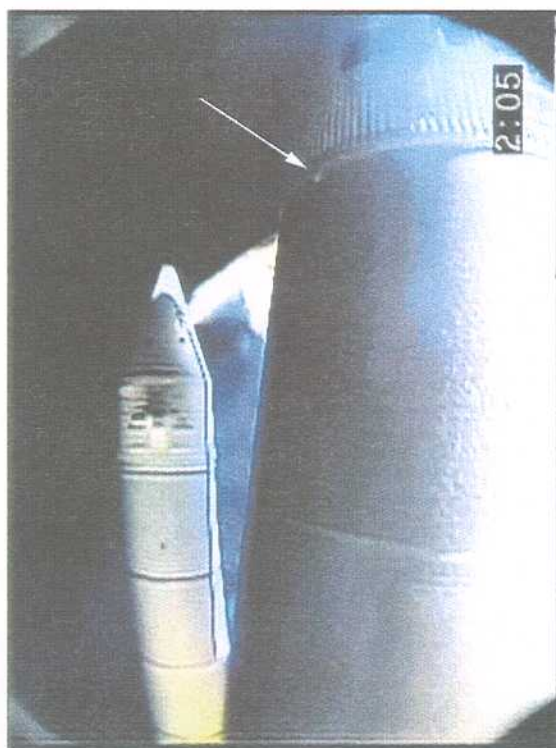
Figure 2.6(B) Divot on -Y LH2-to-intertank Flange Closeout

An approximate 9-inch divot was seen on the -Y LH2-to-intertank flange closeout and the LH2 tank interface aft of the intertank access door (Figure 2.6(B)).
